EVALUATION OF A HIGHLY ANTICLASTIC PANEL WITH TOW OVERLAPS

K. Chauncey Wu
NASA Langley Research Center

ABSTRACT

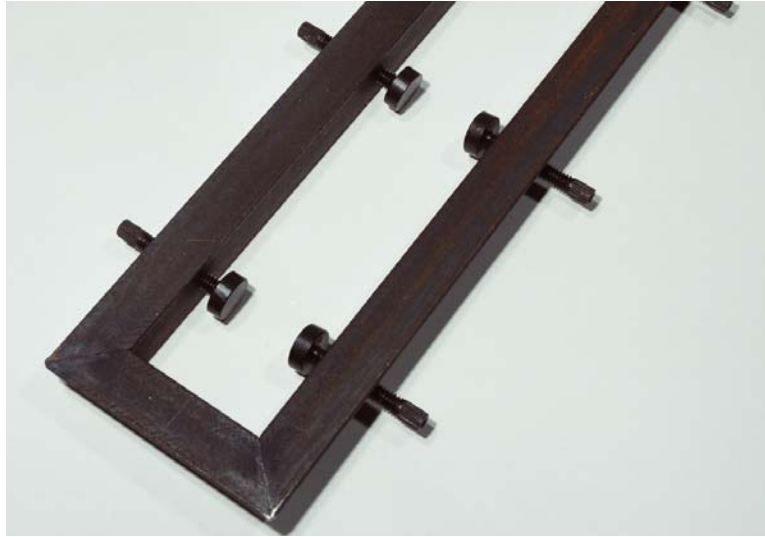
Figure 10. Horizontal edge test fixture.

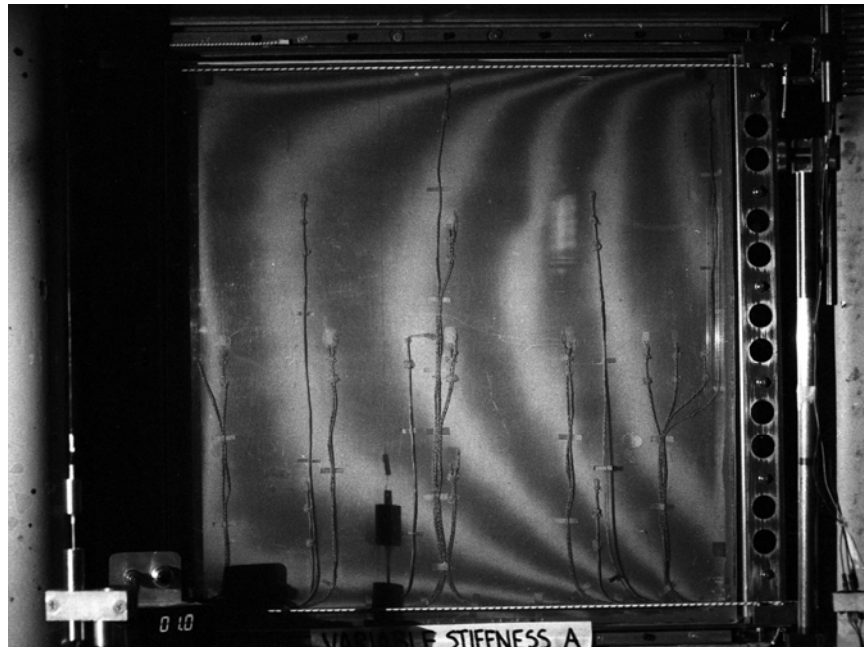
The panel and its attached test fixtures were then installed in a 300 klb-capacity mechanical test stand for the end compression test. The front and back of the panel in the test stand are shown in Figures 15a and 15b. The photograph of the panel front also shows part of the shadow moiré system used for qualitative measurement of the panel normal deflections. Affixed to a clear Lexan sheet mounted in front of the panel, this grid is comprised of a set of thin, equally spaced black lines used to project shadows from a polarized light onto the white-painted front of the panel.

Figure 15a. Front of panel test setup.
